California Public Utilities Commission <i>Mitigation Monitoring, Compliance, and Reporting Program</i>
	Cleveland National Forest Power Line Replacement Projects Compliance Status Report: 012 March 5, 2017

This compliance status report covers construction activities from February 20 through March 5, 2017.

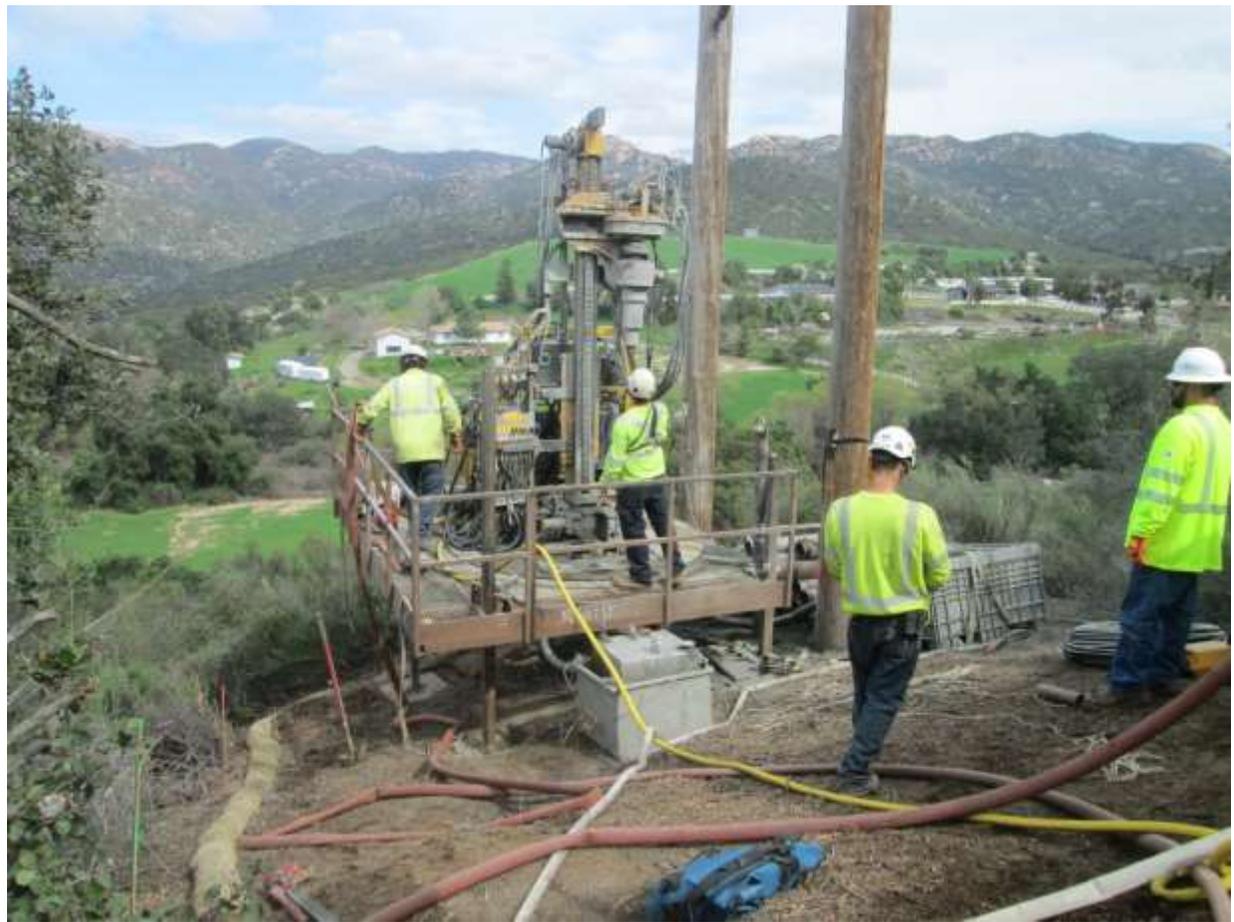
approved access roads, setting up and breaking down drill sites, drilling and installing foundation bars for micropile foundations (See Photo 1—Attachment A), conducting helicopter external load operations in Japatul Spur Staging Yard and along the project alignment to transport drilling equipment to and from work sites for micropile foundations, and establishing the Sweetwater Staging and Fly Yard.

Photo 1: A construction crew observed drilling micropile foundation holes at Pole Z272891 (TL 625B), where helicopter external load operations were used to transport drilling equipment and materials to and from the site.

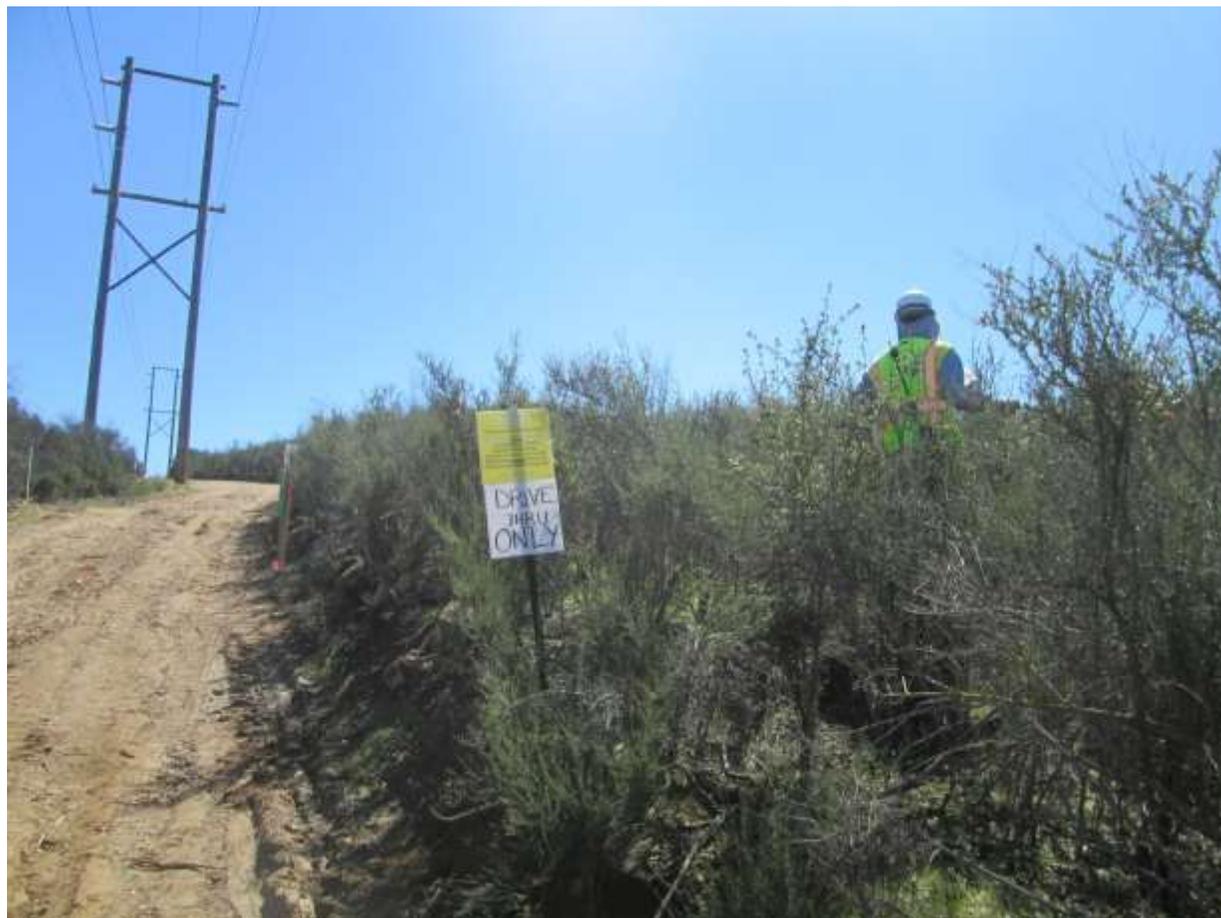
Biological monitors were observed clearing sites prior to construction work, inspecting sites throughout the day, and monitoring vegetation clearing and ground disturbing activities in accordance with MM BIO-3 and MM BIO-22. Construction crews were observed working within delineated workspaces in accordance with MM BIO-1, and ESA signs were observed along the alignment to notify construction personnel of special status plants and butterfly host plant species outside the work limits in accordance with MM BIO-13, MM BIO-14, and MM BIO-16. Construction crews were observed using trash bags to collect trash to be removed from sites daily in accordance with MM BIO-26. In accordance with MM BIO-28 and the Nesting Bird Management Plan, two nesting bird buffers were observed near Z272867 that were designated as “drive through only,” meaning no work is allowed within buffer, and an avian biologist was observed monitoring nesting activity at the nests and ensuring that construction crews complied with buffers (See Photo 2—Attachment A).

Photo 2: During vegetation clearing at Pole Z272867 (TL 625B), an avian biologist was observed monitoring an active bird nest in the vicinity of the work area, and ensuring the implementation of a nesting bird buffer in accordance with the Nesting Bird Management Plan (MM BIO-28).

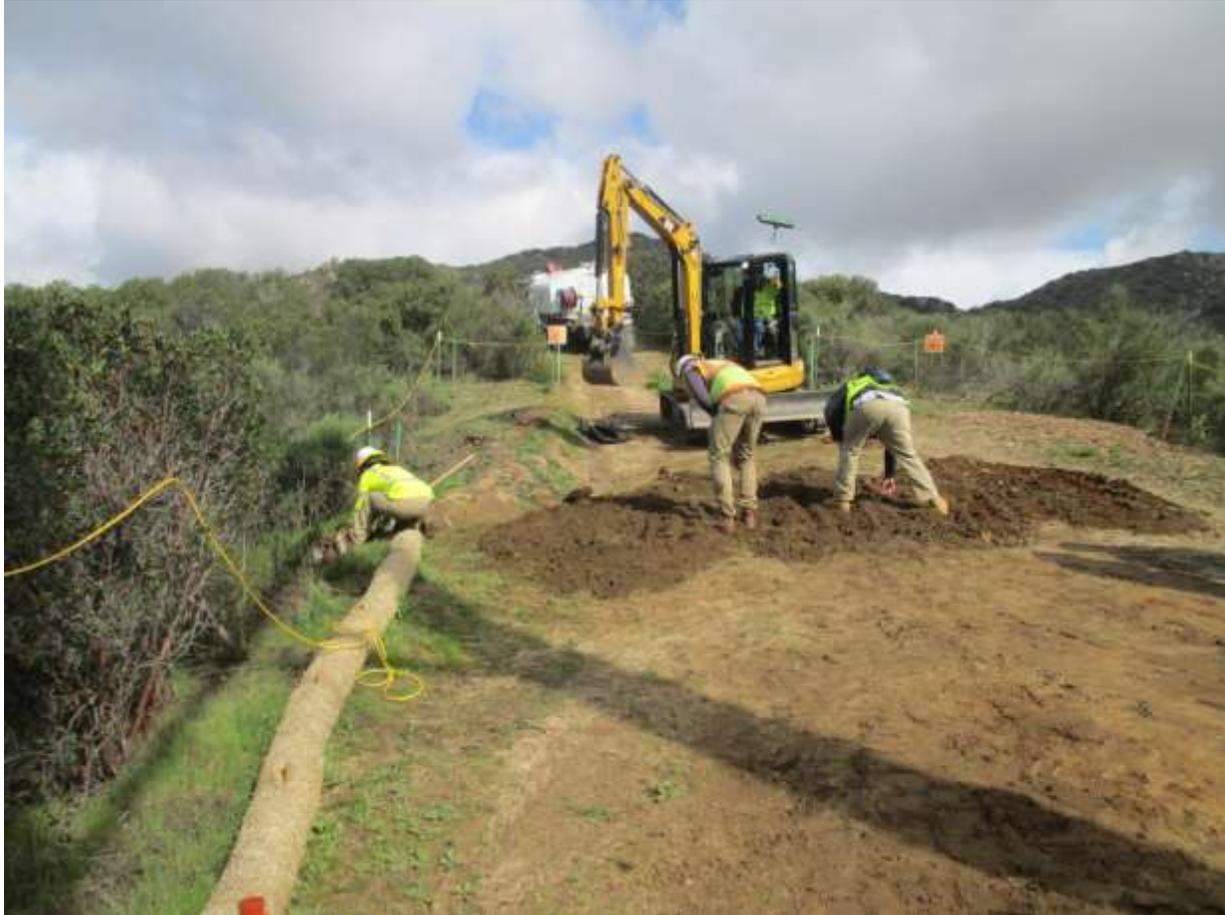
Archeological and Native American monitors were observed monitoring construction activities in work areas within the vicinity of previously recorded cultural resources and in areas identified as having a high potential to contain buried deposits in accordance with MM CUL-1, MM CUL-3, and APM CUL-04. Cultural ESA fencing was observed around the perimeter of workspaces and along the boundaries of access roads in accordance with Historic Properties Management Plan. At required pole sites archeological and Native American monitors were observed inspecting disturbed soils while a construction crew conducted maintenance grading of waterbars (See Photo 3—Attachment A).

Photo 3: During waterbar grading and energy dissipater device maintenance, an archeological monitor and Native American monitor were observed inspecting disturbed soils in accordance with MM CUL-1, MM CUL-3, and APM CUL-04.

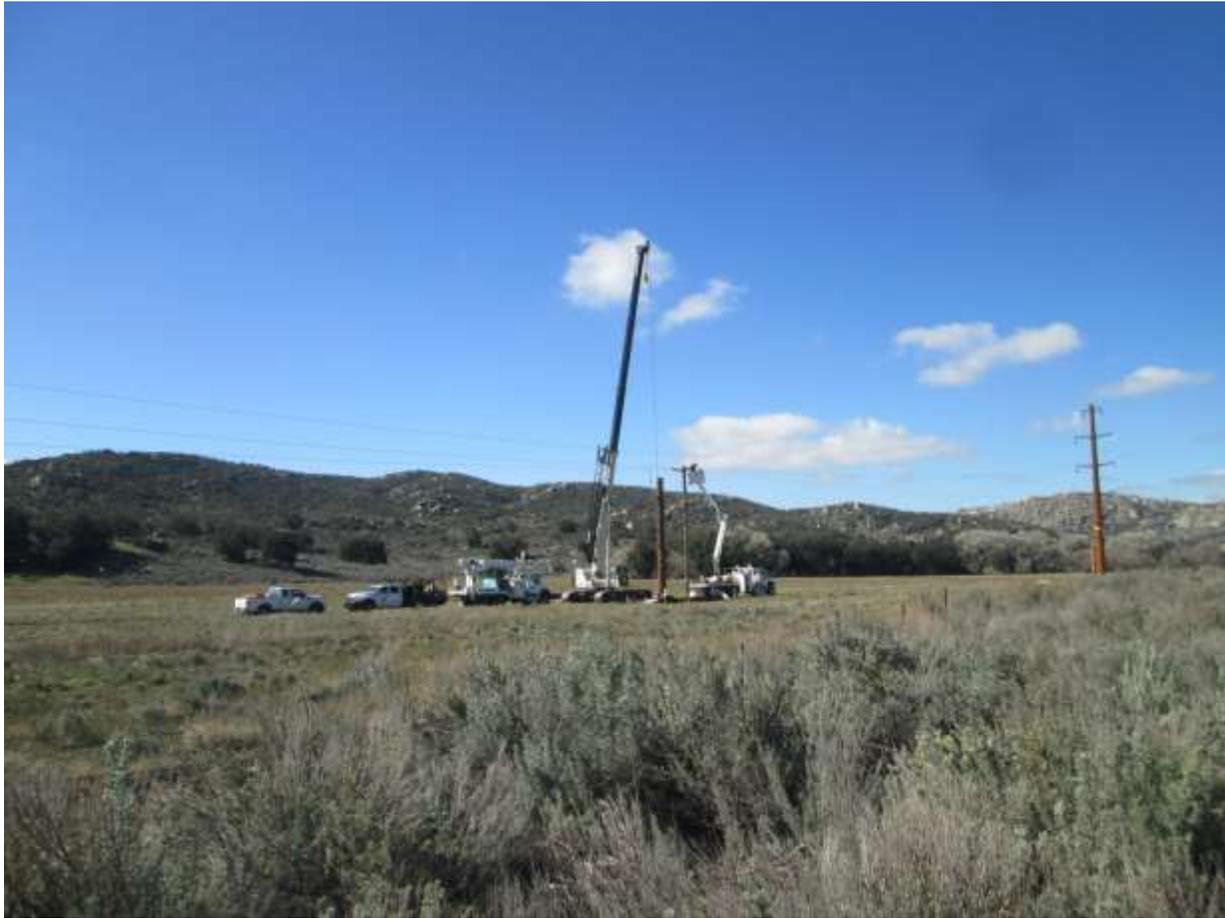
During this reporting period, construction crews were observed grouting for micropile foundations; staging, assembling and installing steel poles (See Photo 4—Attachment A); conducting overhead line work, including wire stringing and transfer, and installing insulators; and clearing vegetation at stringing sites (See Photo 5—Attachment A).

Photo 4: A construction crew observed setting a steel replacement pole at Pole Z44158 (TL 629E).

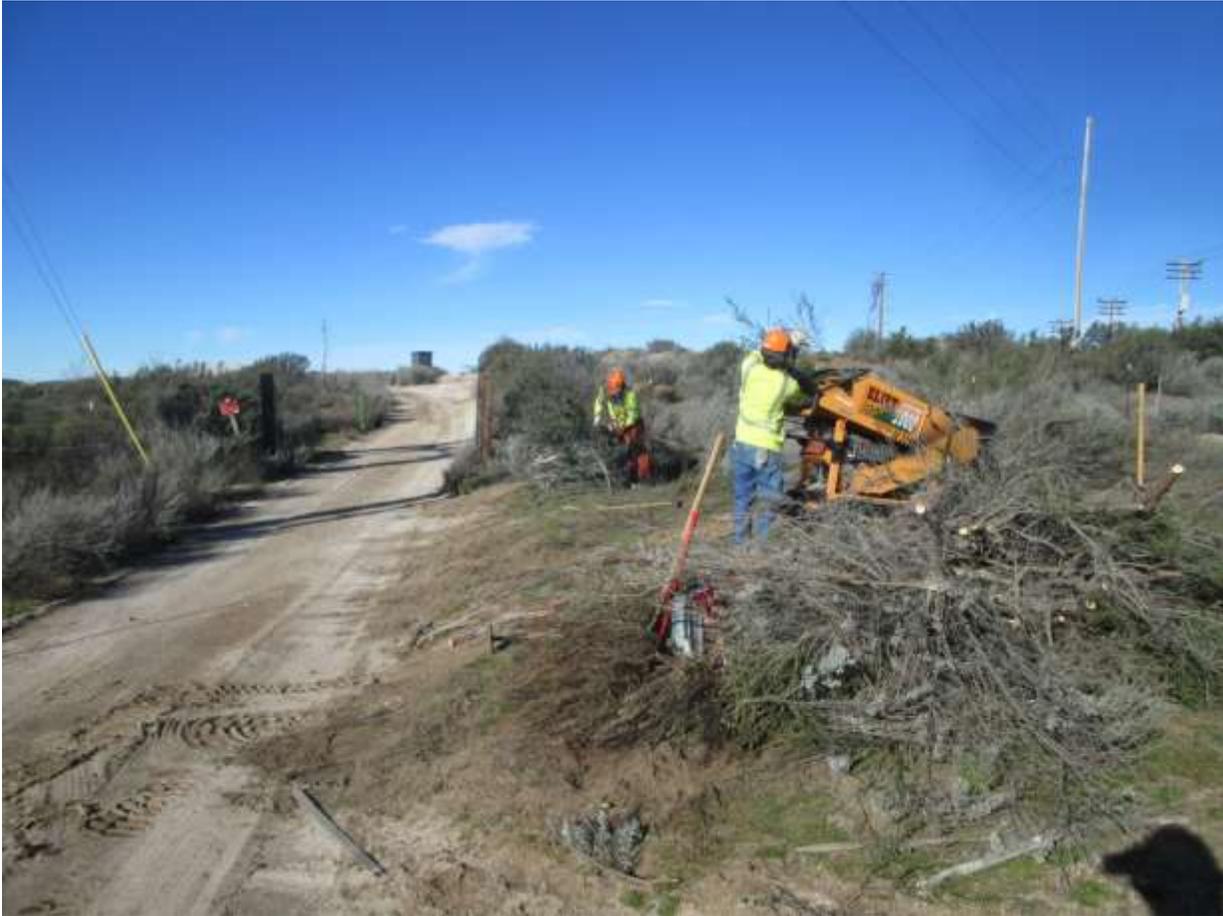
Photo 5: A construction crew observed clearing vegetation at Stringing Site 18 (TL 629E). The activity was confined to the approved and delineated workspace in accordance with the NTP and MM BIO-1.

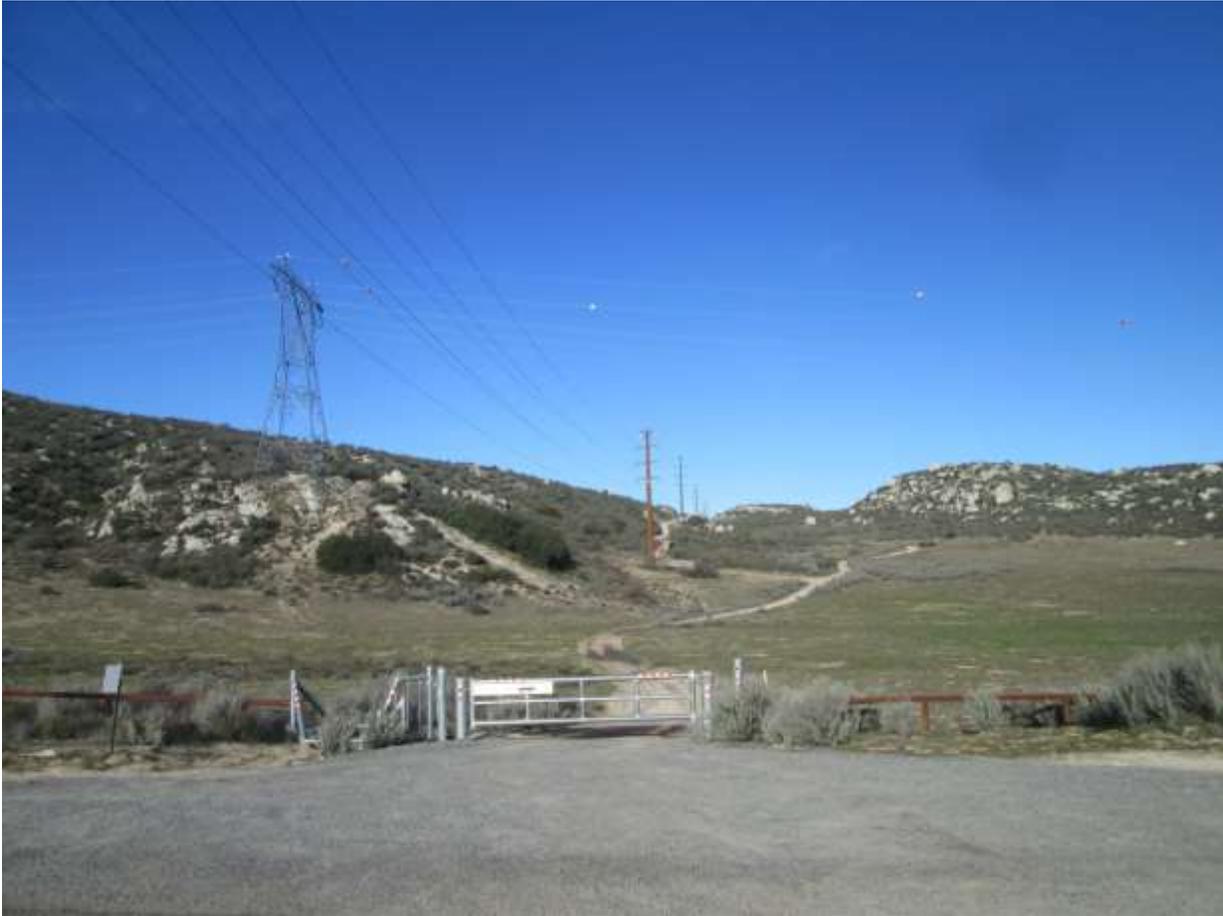
In accordance with MM-REC-2, gates used to access National Forest System lands were kept locked while construction activity occurred (See Photo 6—Attachment A).

Photo 6: In accordance with MM REC-2, a gate used to access Poles Z44171 to Z44162 (TL 629E) was observed locked while construction activity occurred on USFS- managed land.
